# pre purchase report

Daniel Collier / Imagine Inspections

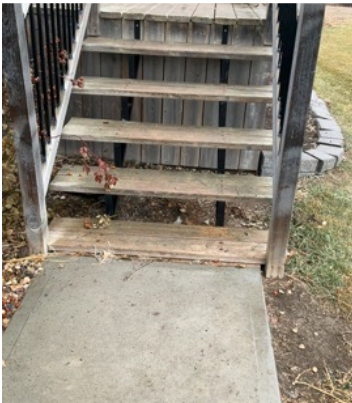
Loose and uneven risers

The front steps have uneven risers, which can pose a safety risk due to the potential for trips and falls. It's important for steps to have consistent riser heights to ensure safe and easy navigation. This condition should be addressed to enhance safety and accessibility.

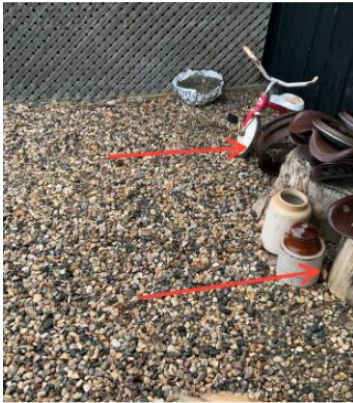
Improper slope. Pitch grading so that the water drains away from the house. The only spot for incorrect grade is by the rear deck, having this area graded correctly would allow for a complete and well sloped area all around the property.

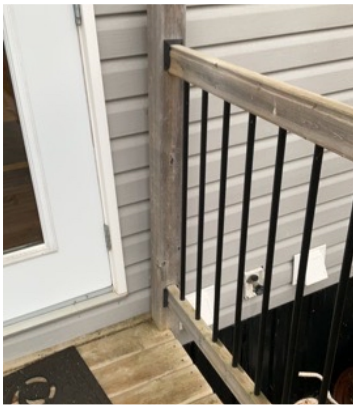
Loose handrails

Both the front and back deck area would benefit from having lag screws placed into the deck railing posts to tighten the system.

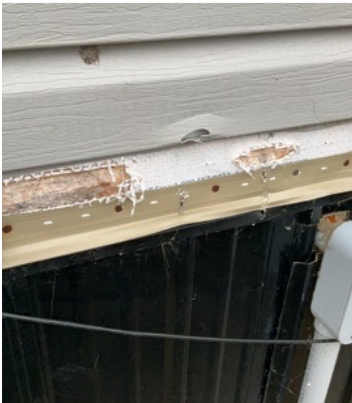
Damaged siding on north side of building

The exterior of the property is missing a piece of siding on the north side with exposed sheathing this can be a spot for water to get into the wall assembly and cause rot

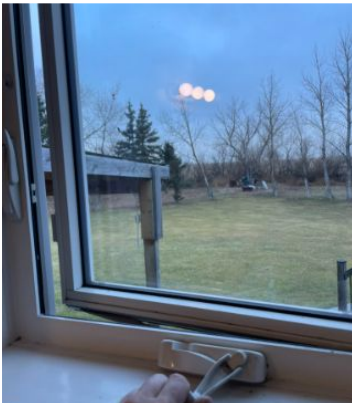
Windows need maintenance and adjustment to make the operation smoother

The windows on the exterior of the property require maintenance and adjustment to improve their operational smoothness. The current condition may lead to difficulties in opening and closing, potentially impacting functionality and efficiency. Regular maintenance will help ensure longevity and optimal performance.

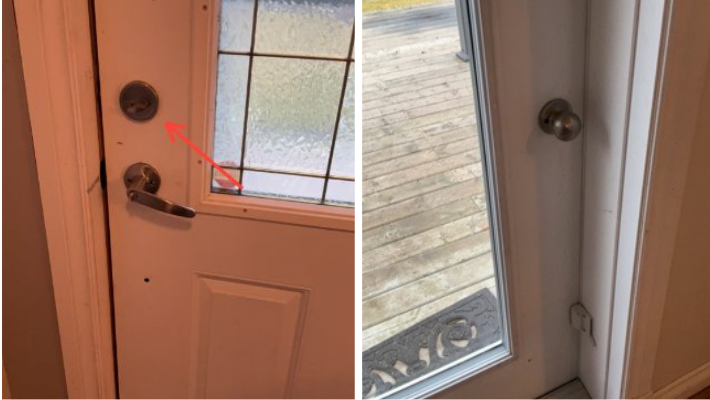
During the inspection of the exterior, it was observed that the locks and seals require adjustments to ensure smooth and efficient operation. Proper alignment and sealing will help

maintain security and weatherproofing of entry points, contributing to the overall functionality and longevity of the property.

Recommend locking handle be installed

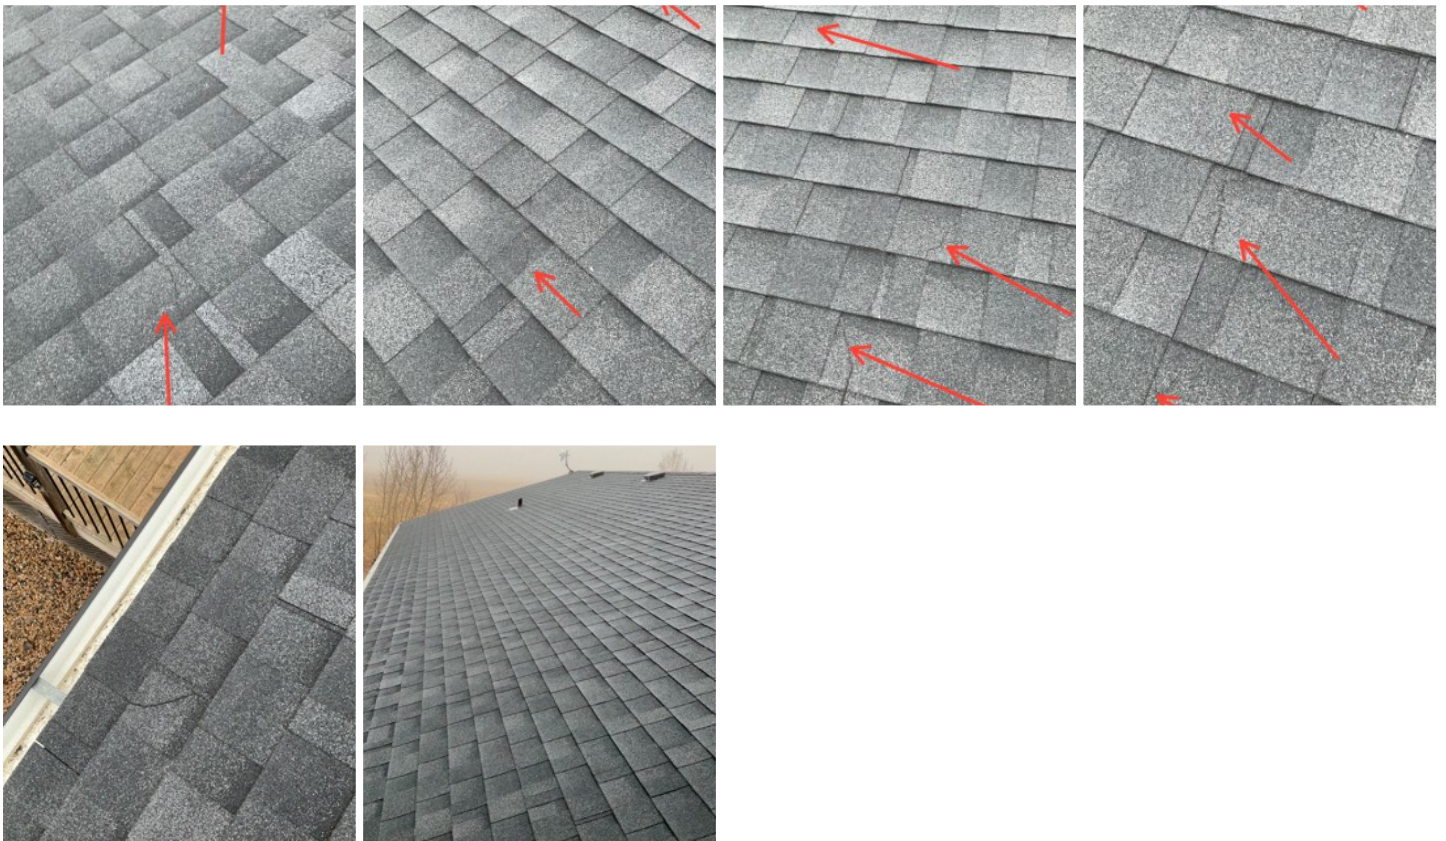
Shingles have wind damage

### Wind Damage to Roof Covering – Diagonal Shingle Cracking

Evidence of **wind-related damage** was observed on the roof covering. Several shingles showed **diagonal cracking patterns**, which are consistent with **uplift stress** caused by high winds. This type of damage often occurs when wind forces flex the shingle beyond its tolerance, creating fractures that weaken its protective function.

The affected shingles are now **compromised**, increasing the potential for **water infiltration, premature deterioration, and further wind loss** during future storms.

#### Recommendation:

A **qualified roofing contractor** should further evaluate the roof and repair or replace all damaged shingles as needed. Timely correction is advised to prevent moisture intrusion and extend the roof's remaining service life.

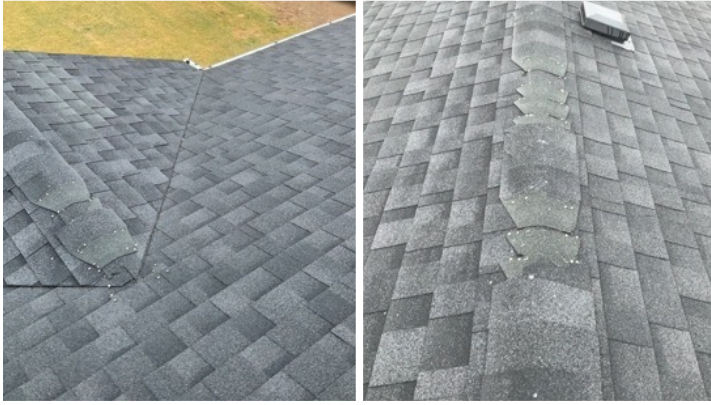
Requires Attention

Damaged shingle at end of ridge line

During the inspection, a damaged shingle was observed at the end of the ridge line. This could potentially lead to water infiltration and further deterioration if not addressed. It is important to monitor this area for any signs of leaks or additional damage over time.

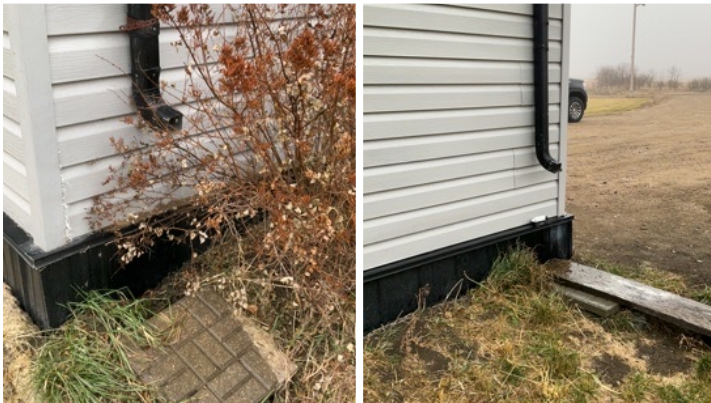
Maintenance

Extend drain(s) to move water away from foundation

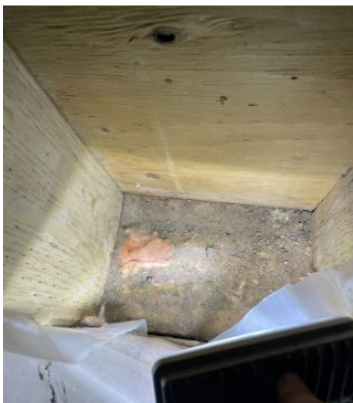
PWF foundation

Permanent Wood Foundation (PWF) – Description and Client Guidance

The home is constructed on a **Permanent Wood Foundation (PWF)**, sometimes also referred to as a **Preserved Wood Foundation**. This type of foundation uses **pressure-treated / preserved wood framing and sheathing below grade**, designed to resist moisture and decay when properly installed and drained.

At the time of inspection, **only limited portions of the PWF were visible**. Most of the foundation is concealed behind finishes, insulation, and/or soil and cannot be fully evaluated during a visual home inspection. The long-term performance of a PWF depends heavily on **proper original construction** and **effective moisture management**.

The wood Foundation appears to be working correctly and and has been built in a hybrid form that would help with the structure, The slab in the basement stops the system from moving inwards.

### Recommendation:

Due to the concealed nature of this type of foundation, my clients should understand that **only a limited visual review is possible** during a home inspection. They should budget for **regular monitoring and maintenance of grading, drainage, and moisture control measures** to help support the long-term performance of the PWF.

The seller should have engineering for the system that they built, This would show what system was used and confirm the suspected good quality of the installation.

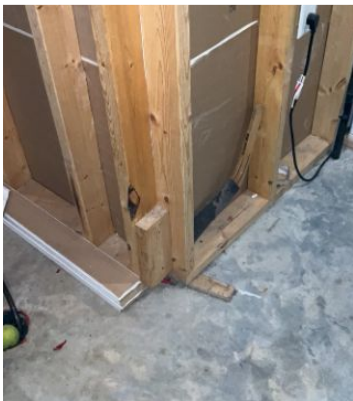
During the inspection it was noted that the **interior basement stud walls are framed tight between the concrete floor slab and the floor structure above**, with no visible “floating” gap or slip detail. In many parts of Saskatchewan, including areas with expansive clay soils, **current building practice is to construct interior basement walls as “floating walls”**. This typically means leaving a gap of about **½" to 1" between the top of the interior wall and the floor framing above**, or otherwise detailing the wall so it can move independently from the slab. [Saskatoon+1](#)

Floating walls are used to allow for **independent movement of the basement slab** due to soil-related heaving or settlement, which is a known concern in local clay (“gumbo”) conditions. Where walls are rigidly fastened between the slab and structure above, movement of

the slab can **stress wall framing, crack drywall or finishes, affect doors and trim, and in some cases transfer unintended loads to the floor system.**

Because interior conditions, soil behaviour and slab performance can vary from house to house, the inspector **cannot predict future movement or performance** of these non-floating walls.

In further to this narrative we have used AI to confirm if this a NBC code requirement, and it is not required just best practise.

We still believe that it has the potential to cause shifting due to the clay soil in the area and our own experience.

**Recommendation:**

My clients should be aware that the current interior basement wall construction **does not follow typical modern “floating wall” practice used in many Saskatchewan municipalities for basements over expansive clay soils.** They should consult the **local building authority and/or a qualified contractor familiar with Saskatchewan basement construction** to determine if any modifications are recommended before further finishing or renovation, and to discuss options for monitoring and addressing potential slab movement (cracks, heaving, doors binding, drywall cracking, etc.) over time.

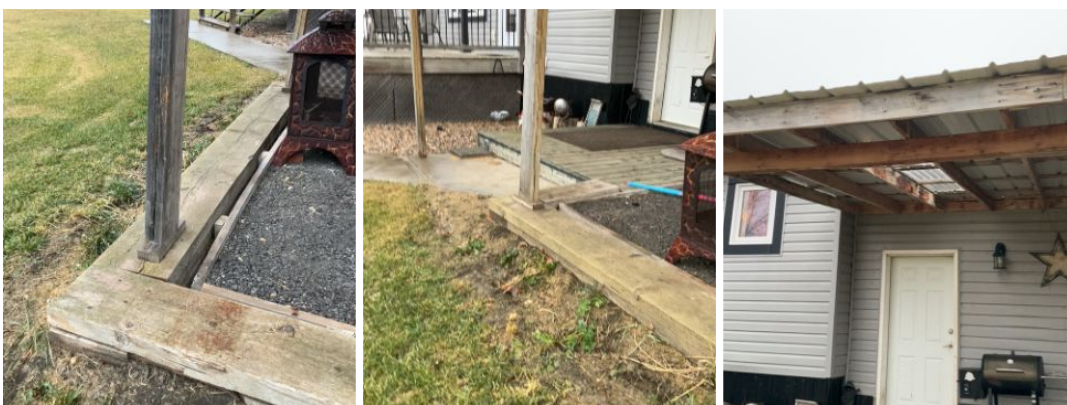
An **exterior lean-to style structure** was observed attached to the main building. Based on its visible construction and detailing, this addition **does not appear to meet current building code or typical construction practice** for attached structures. Examples of concern may include **foundation support, framing, roof connection to the primary structure, and weather protection/flashings.**

Because the lean-to is **physically attached to the home**, any deficiencies in its design or construction may affect **durability, weather resistance, and potentially the performance of the adjacent exterior wall and roof** of the main building. The presence of non-conforming or unpermitted structures can also impact **insurance coverage, resale, and future renovation plans.**

**Recommendation:**

- Confirm whether permits and final approvals were obtained for this addition.
- Evaluate the structure for **safety, structural adequacy, and weather protection.**
- Determine what **repairs, upgrades, or possible removal** may be necessary to bring the property into compliance with current standards and local requirements.

Repairs or modifications should be completed by **qualified contractors** under any required permits.

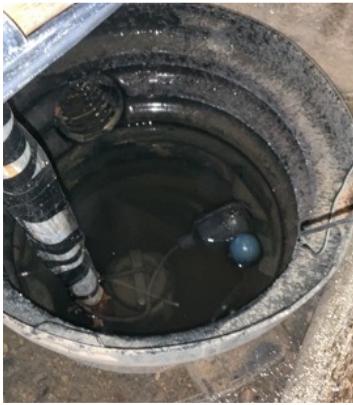
Recommendation

Sump float valve too high weeping tile system would fill before pump out

During the inspection, it was observed that the sump pump's float valve is set too high, which can cause the weeping tile system to fill up before the pump activates. This can lead to potential overflows and water damage. It is recommended to adjust the float valve to a lower position to ensure timely activation of the pump. If you are unfamiliar with this adjustment, consult a licensed plumber to properly correct the setting and evaluate the overall system for any additional issues. Regular maintenance checks are advised to prevent future problems.

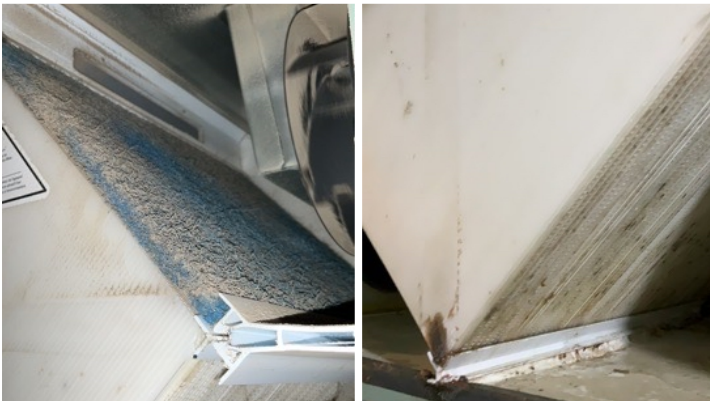
Maintenance

HRV filter needs cleaning

The HRV filter requires cleaning, as it appears to be significantly clogged with dust and debris. This can hinder airflow and reduce system efficiency. It is recommended to clean or replace the filter to ensure optimal performance and indoor air quality. Check the manufacturer's guidelines for cleaning frequency and methods.

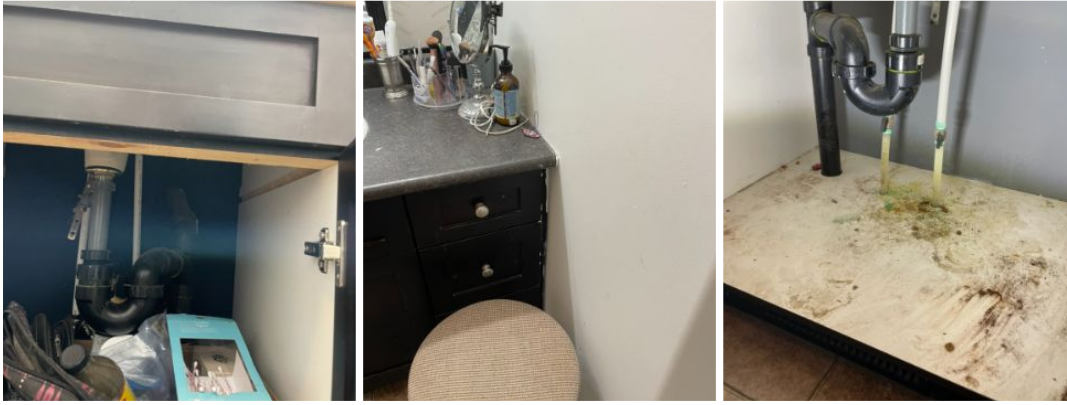
Vanities through out had typical wear and require maintenance

The bathroom vanities exhibit typical wear and tear, indicating the need for routine maintenance. It's recommended to clean all surfaces regularly, check for signs of water damage, and ensure seals around sinks and countertops are intact. Consider refinishing or repainting if cosmetic issues persist to maintain the vanities' appearance and functionality.

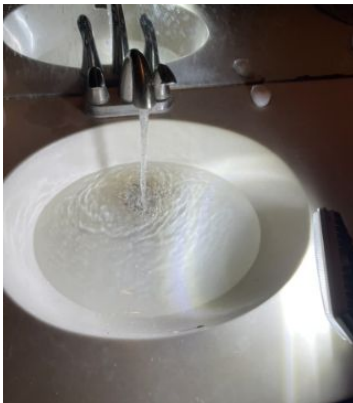
Bathroom sink slow draining/ missing stopper

During the inspection, it was observed that the basement bathroom sink drains slowly and the stopper is missing. This can lead to potential water pooling and drainage issues. It is recommended to evaluate and address the slow drainage and install a new stopper to ensure proper functionality. Regular maintenance will help prevent future drainage problems.

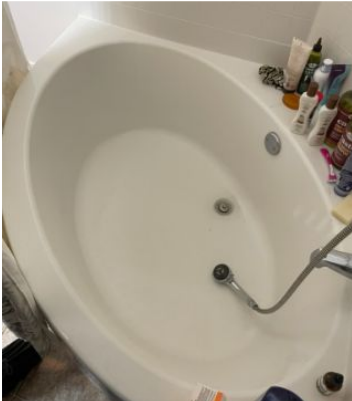
**Recommendation**

Master bathroom tub is large for the size of the hot water tank

The master bathroom tub is notably large in relation to the size of the existing hot water tank. This may result in inadequate hot water supply for filling the tub, potentially affecting user experience and comfort. Consideration of this discrepancy is advised for optimal performance and convenience.

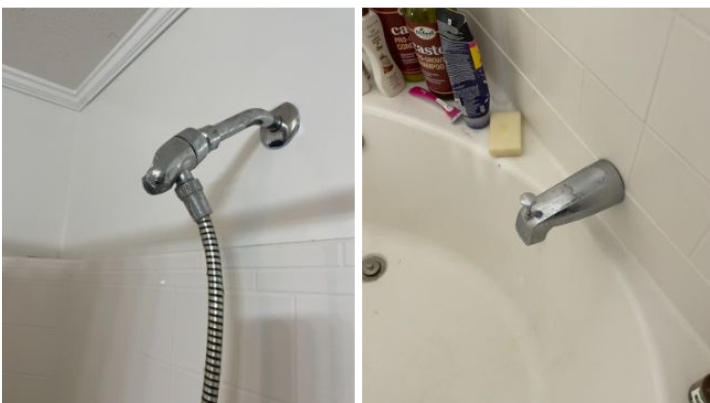
**Maintenance**

Shower heads and faucet spout need adjustment /replacment

The shower heads and faucet spout in the bathroom require attention. The shower heads appear to be leaking and may not be operating efficiently, while the faucet spout shows signs of wear and may need adjustment or replacement to ensure proper water flow and prevent further issues. These components should be evaluated further to determine the best course of action.

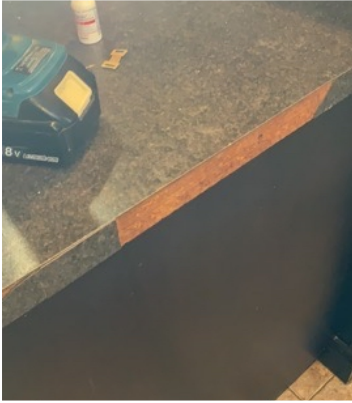
Water damage present under the counter

## Surface laminate loose or peeling

Island countertop

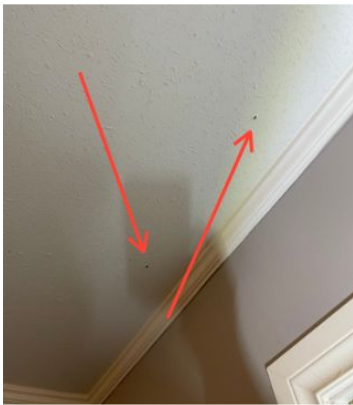
Nali pops in southwest bedroom ceiling

Nail pop(s) observed

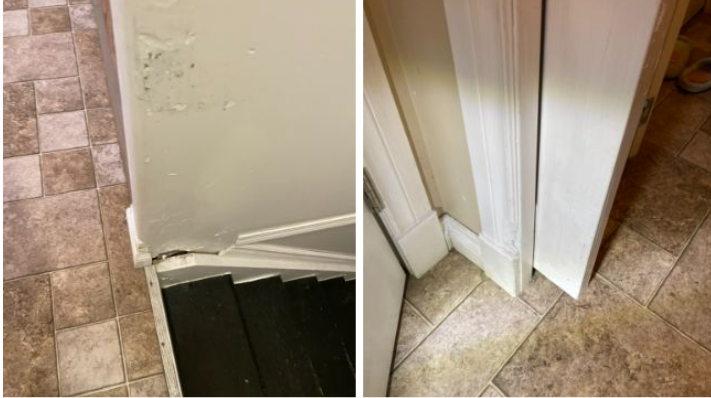
The walls throughout the home display typical signs of wear and tear, including minor scuffs, chips, and some nail holes from previous decorations. It is recommended to patch and repaint the walls to enhance their appearance and protect against further damage. Regular maintenance and touch-ups will help preserve the interior condition. Consider hiring a professional for a thorough evaluation and repair if any larger issues are noted.

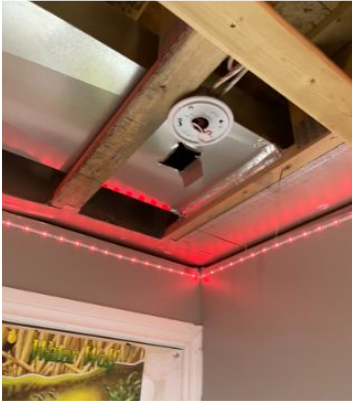
For new installations, both battery-operated and hardwired models are available. Battery-operated units are simple to install and ideal for retrofitting older homes. Hardwired models offer interconnected systems where all alarms sound simultaneously when one detects smoke, providing maximum coverage and safety.

Replacing old yellow smoke detectors isn't just about compliance—it's about ensuring your family's safety with reliable, modern technology. Regular maintenance and timely replacements keep your home prepared for emergencies while adhering to fire safety standards.

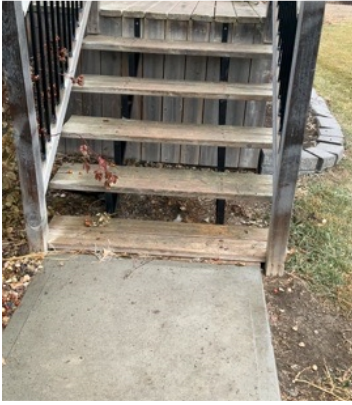
Loose and uneven risers

The front steps have uneven risers, which can pose a safety risk due to the potential for trips and falls. It's important for steps to have consistent riser heights to ensure safe and easy navigation. This condition should be addressed to enhance safety and accessibility.

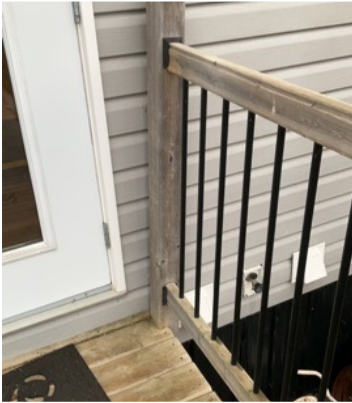
Loose handrails

Both the front and back deck area would benefit from having lag screws placed into the deck railing posts to tighten the system.

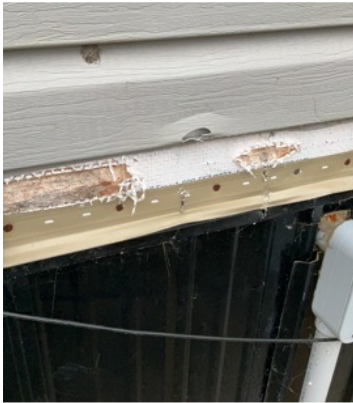
The exterior of the property is missing a piece of siding on the north side with exposed sheathing this can be a spot for water to get into the wall assembly and cause rot

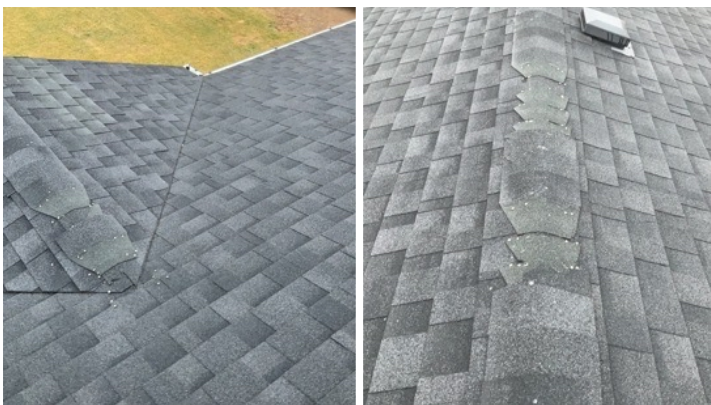
Requires Attention

**Damaged shingle at end of ridge line**

During the inspection, a damaged shingle was observed at the end of the ridge line. This could potentially lead to water infiltration and further deterioration if not addressed. It is important to monitor this area for any signs of leaks or additional damage over time.

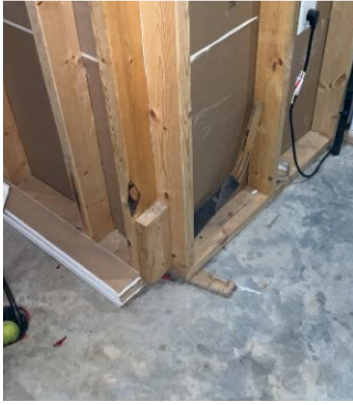
In further to this narrative we have used AI to confirm if this a NBC code requirement, and it is not required just best practise.

We still believe that it has the potential to cause shifting due to the clay soil in the area and our own experience.

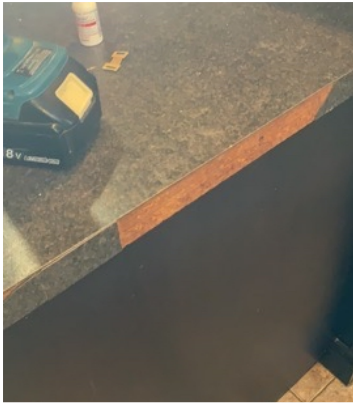
Future service items

Surface laminate loose or peeling

Island countertop

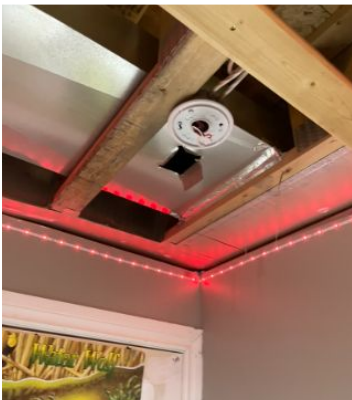
For new installations, both battery-operated and hardwired models are available. Battery-operated units are simple to install and ideal for retrofitting older homes. Hardwired models offer interconnected systems where all alarms sound simultaneously when one detects smoke, providing maximum coverage and safety.

Replacing old yellow smoke detectors isn't just about compliance—it's about ensuring your family's safety with reliable, modern technology. Regular maintenance and timely replacements keep your home prepared for emergencies while adhering to fire safety standards.
